DATE:	December 21 st , 2015
FROM:	Joe Harrington
SUBJECT:	December 2015 Weekly Progress Report @ Gold King
TO:	Steven Way

Project: Gold King Interim Water Treatment Plant

Report No.: 1

Prepared for: Emergency Response Unit – US EPA Region 8

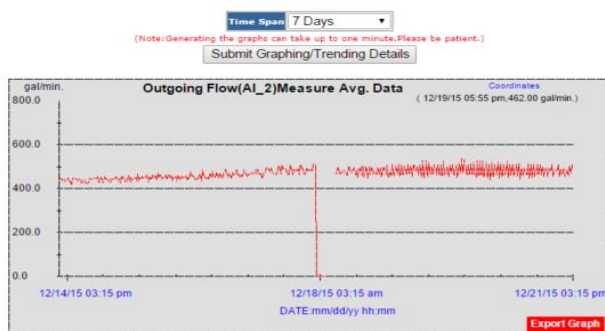
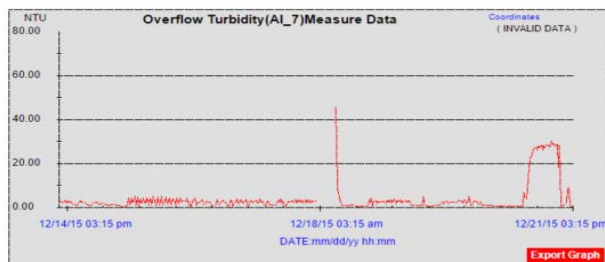
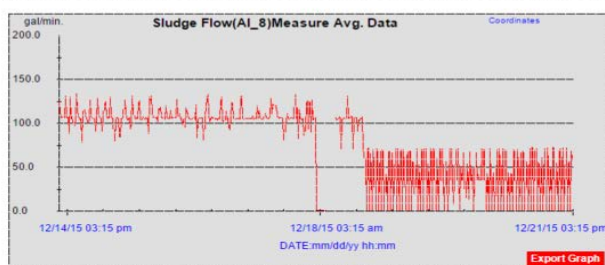
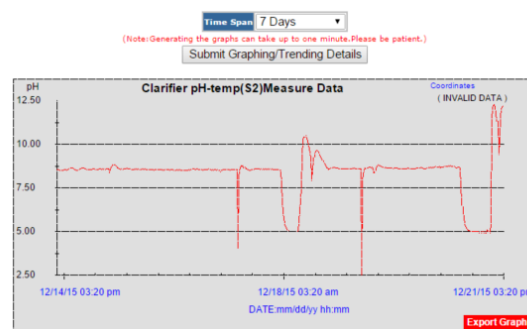
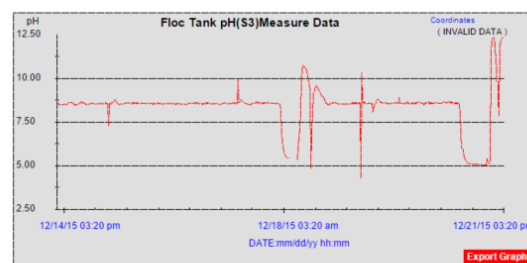
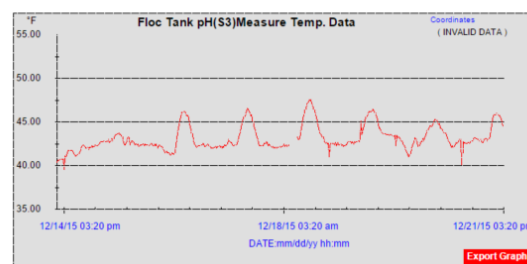
- Alexco experienced a genset failure from 5:00am to 9:00am on 12/18/2015. The on-site operators installed the backup genset to continue operations. Wagner Rents has since fixed the primary genset.
- A plug occurred on 12/21/2015 of the lime slurry pipeline which was cleared by the operator. The plugging was a result of very low dosages of lime slurry required (and no plugging was noted previous to this issue since 10/21/2015). If this issue re-occurs Alexco will substitute a narrower ID tube to ensure that line velocity is maintained from the lime slurry tank to the dosing pump.
- The following data was collected from both the Flow Circuit and Lime Circuit PLC's at the Gold King IWTP.

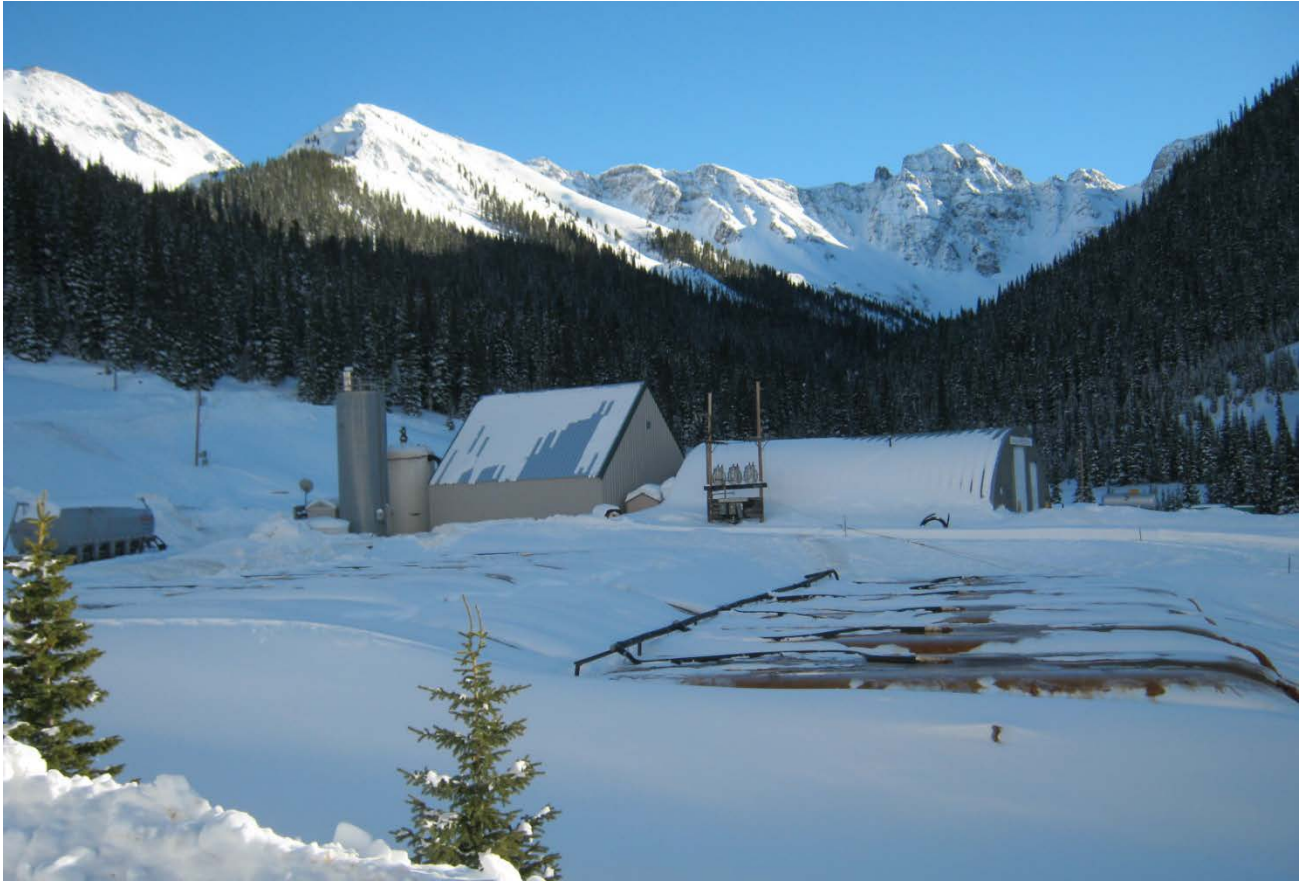
Photo 1 – Taken 12/18/2015, view from Cement Creek towards IWTP.

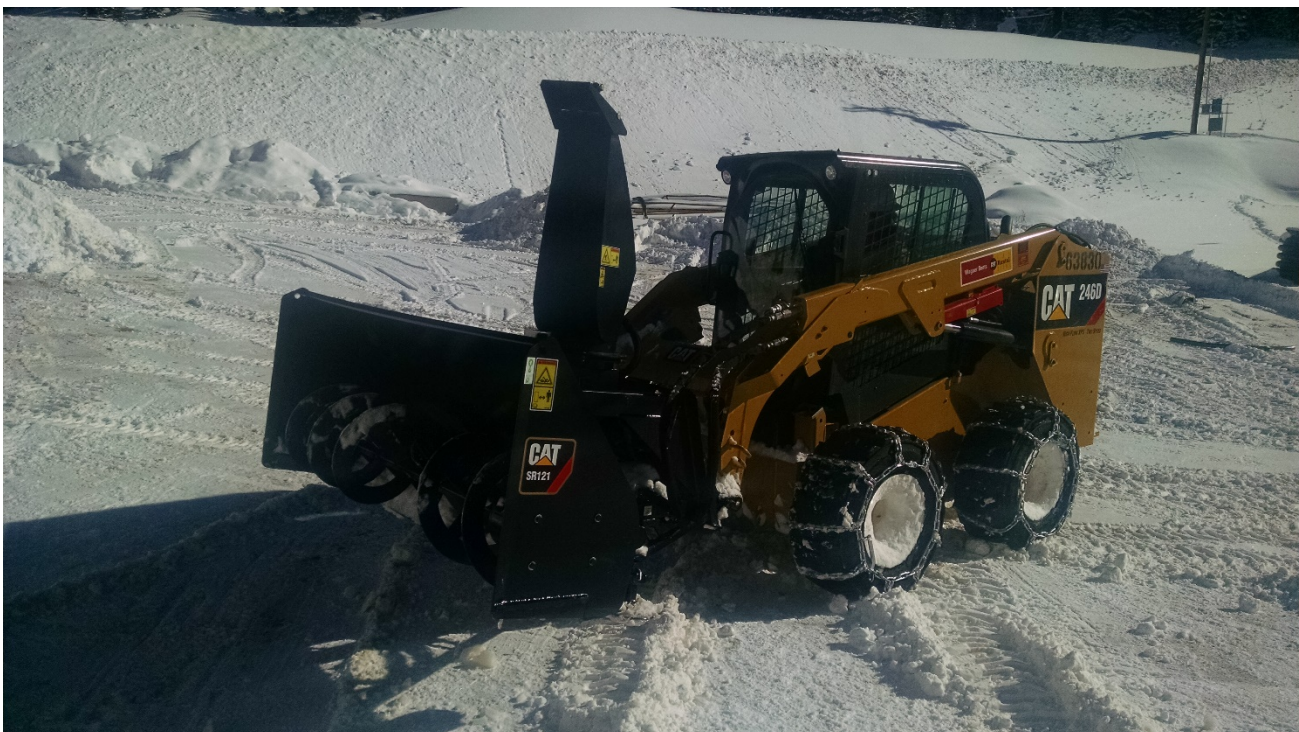
- Alexco currently employs two FTEs who live in Silverton that oversee operations at Gold King IWTP.
- Alexco has rented a skidsteer/blower (see Photo 2) to support snow removal through the winter. In addition, Alexco contacted the county and received confirmation that Alexco personnel can operate the skidsteer/blower and travel on the county roads without violating the prohibition against off-road vehicle usage.

Photo 2 –Alexco's snow removal equipment.

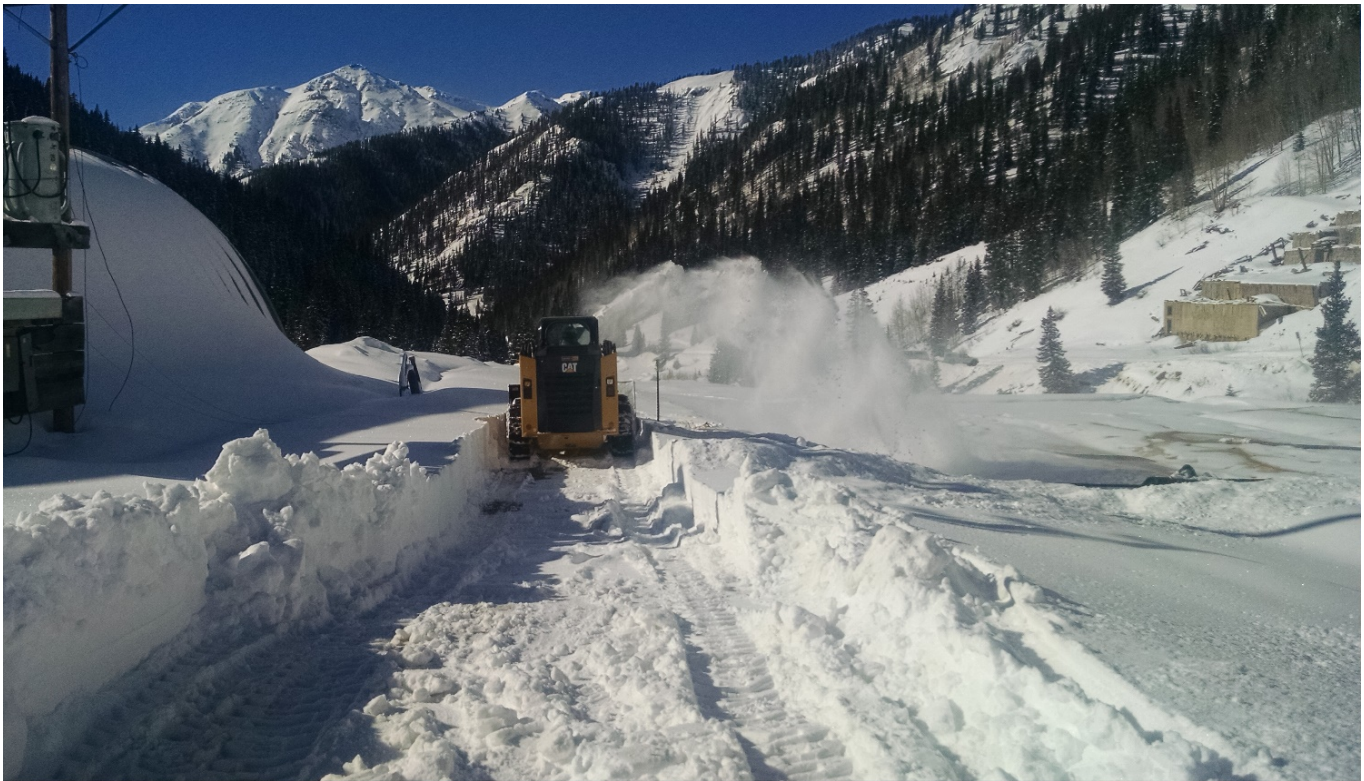
Photo 3 –Alexco's snow removal equipment in use.

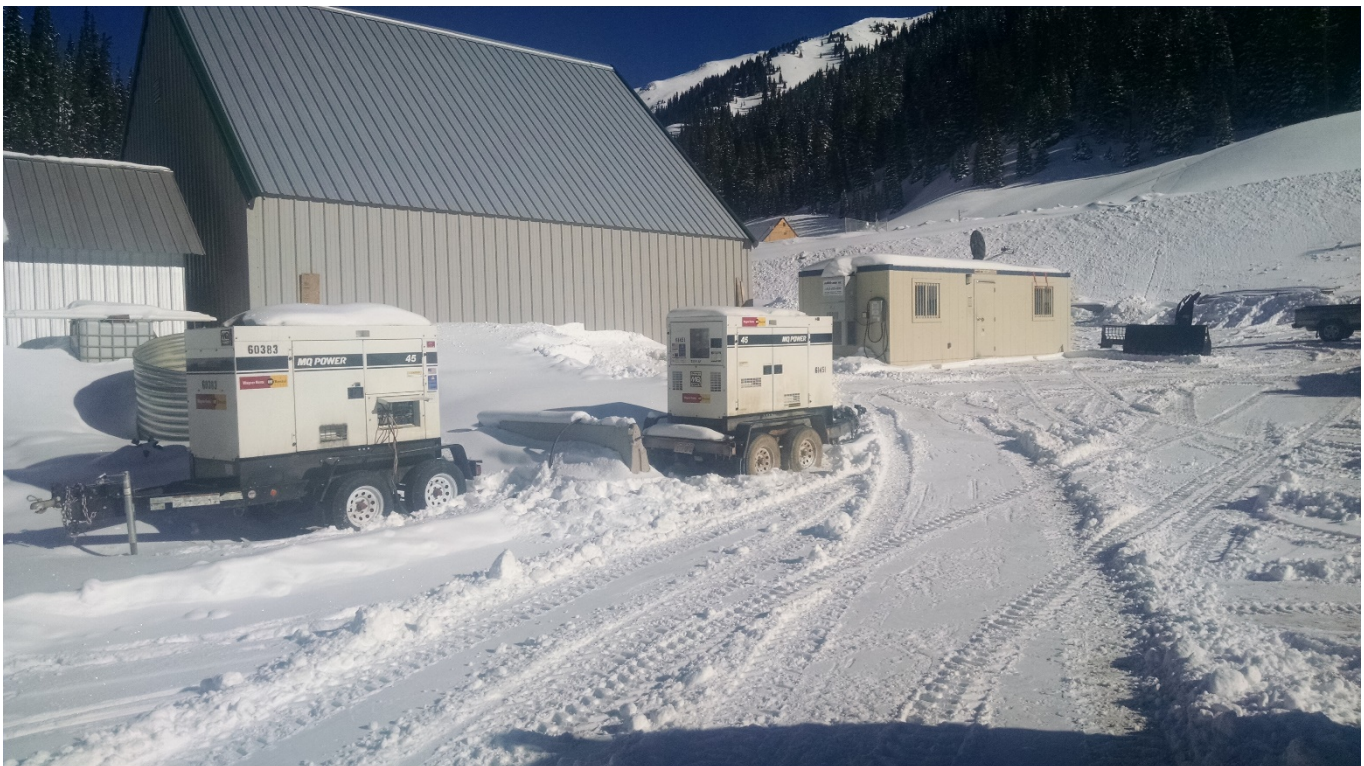
- Repeated Genset Failure: Alexco currently has three electricians at Gold King who are diligently working to transition the system to grid power with an automatic transfer switch for genset back-up.
 - The electrical inspector from Durango is scheduled to inspect the site on 12/23/2015 assuming the site is accessible (large snow storm coming this week).
 - Precision Electric has contacted San Miguel Power to schedule connection to grid power post inspection. Waiting to hear on San Miguel's availability.

Photo 4 –Taken on 12/18/2015, Alexco's genset and back-up unit.
